# All Pro Home Inspections

Date of Inspection: Monday, July 07, 2014

**8 Pond View  
Montville, NJ 07045**

## HOME INSPECTION REPORT

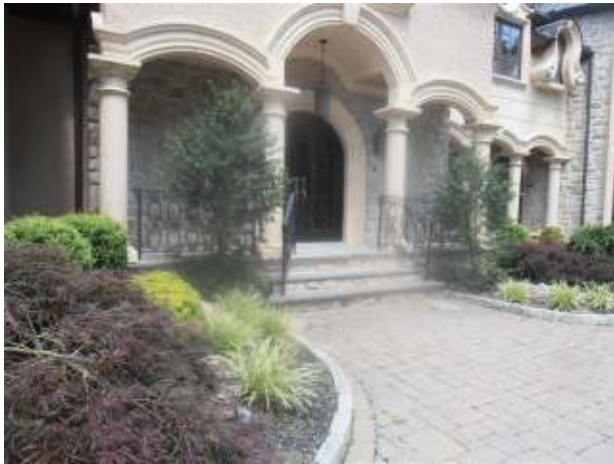
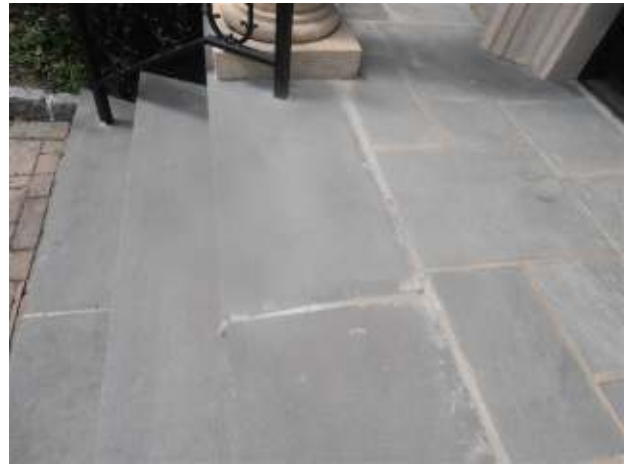
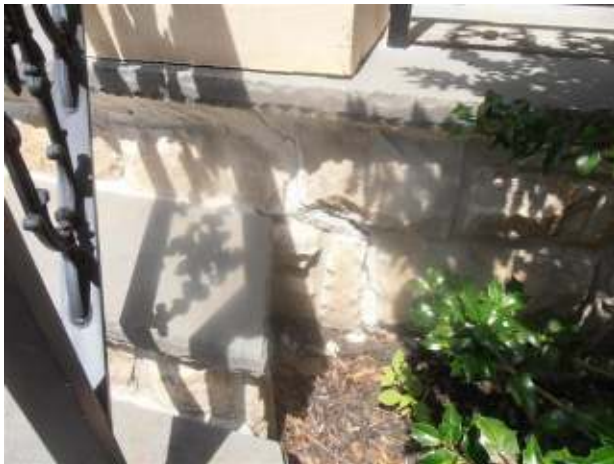
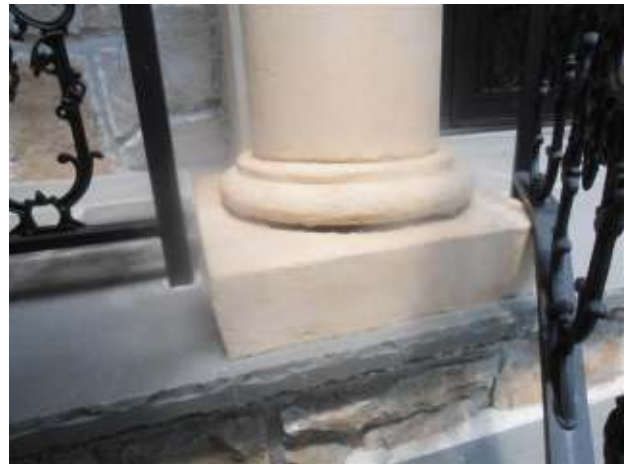
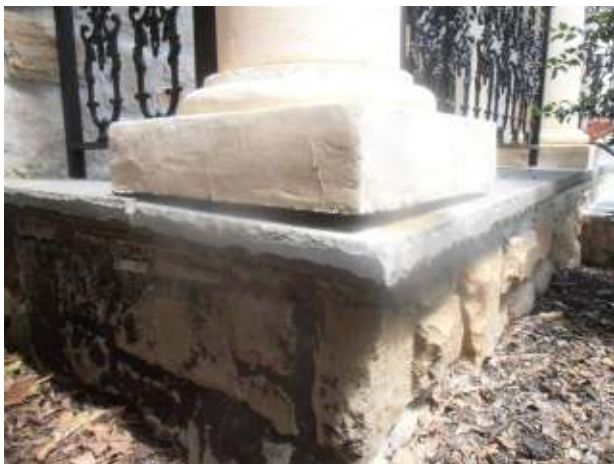
The front entrance area steps and landing that has settled more than normal causing several structural issues needs correction. As with any movement of this type monitoring will be required by a structural engineer to determine exactly what corrective action will be required. If this condition is not corrected more damaging cracks can develop over time. This settlement has cause the far left side column to become loose and is no longer touching the surface, the left column is separating at the base, the top slate is no longer level with the mortar between the slate cracking and there is a crack in the front wall of the steps.

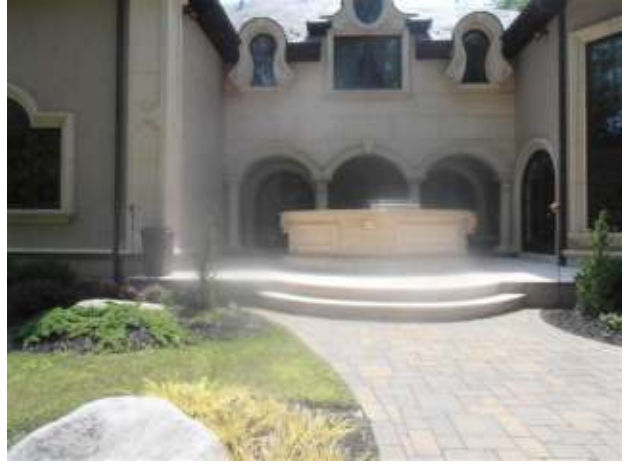
The rear steps need to have railings installed on both sides.

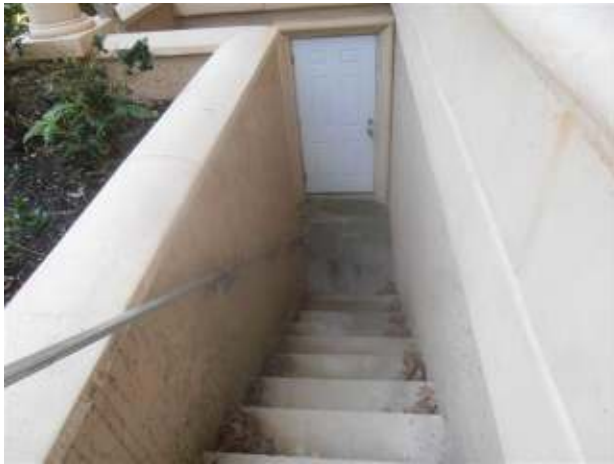
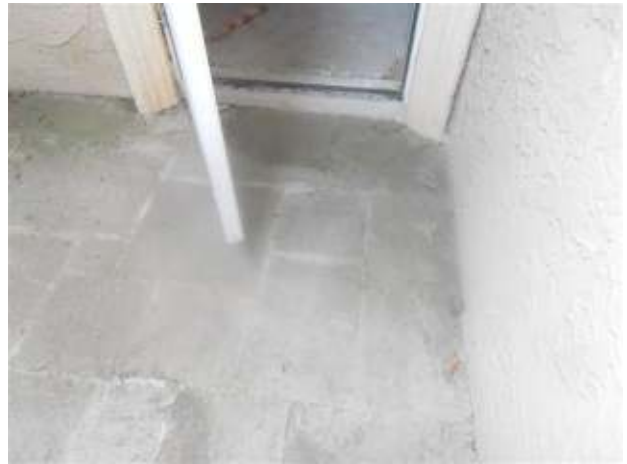
The steps to the basement are in sound condition. No drain is provided at the bottom of the steps that can cause water issues in the basement. This will need to be checked during heavy rainfall. No evidence or signs of any significant water problems are noted.

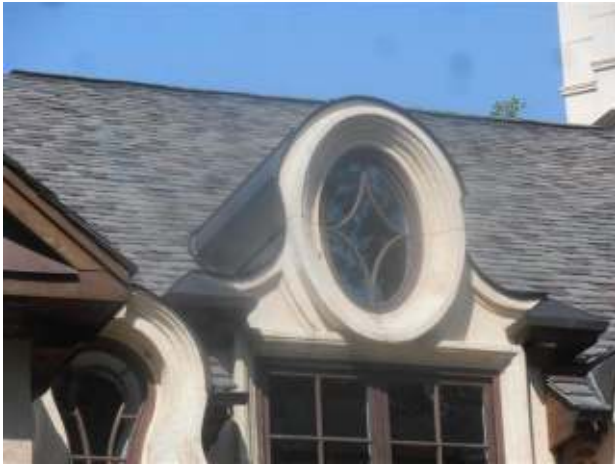
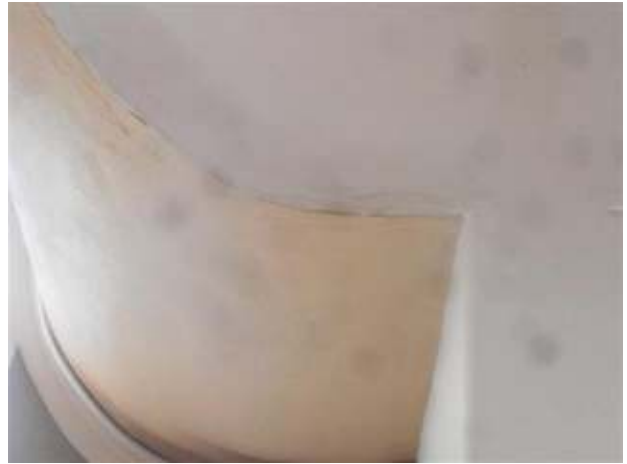
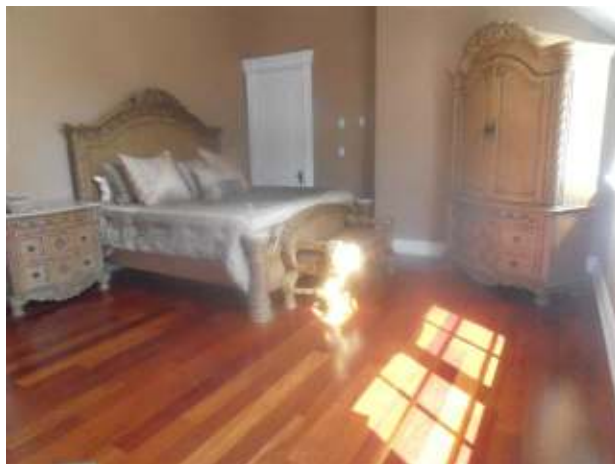
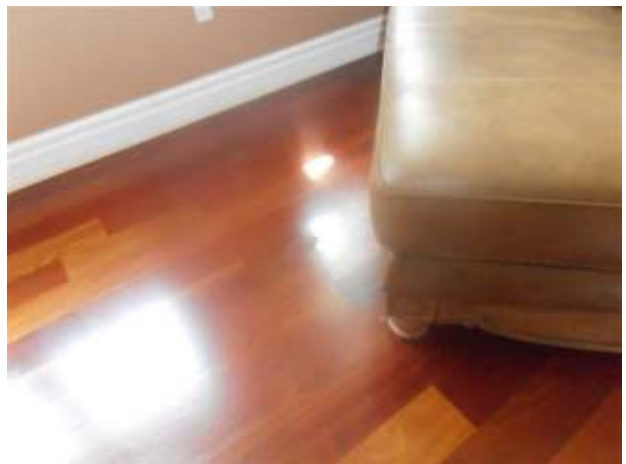
There is evidence of a leak in the front bedroom from ice damming over the winter that needs repair. The slates will need to be removed around this area to installed better flashing and ice and water shield to prevent this leak from occurring again.

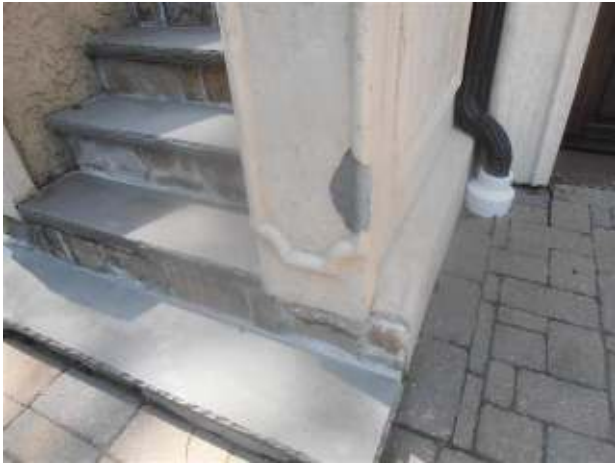
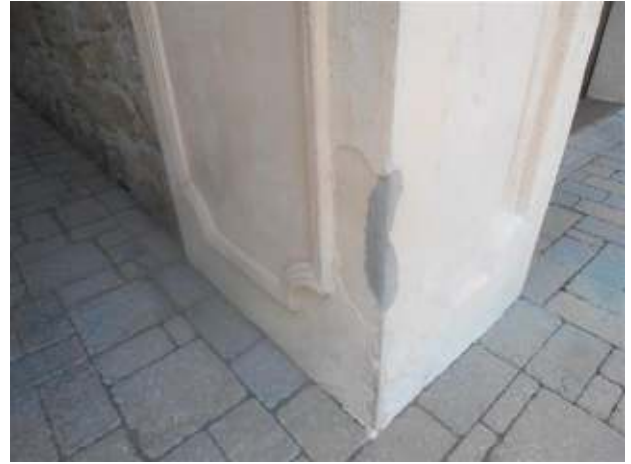
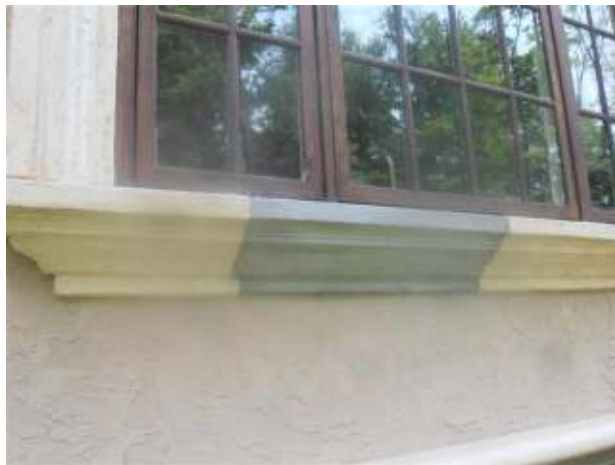
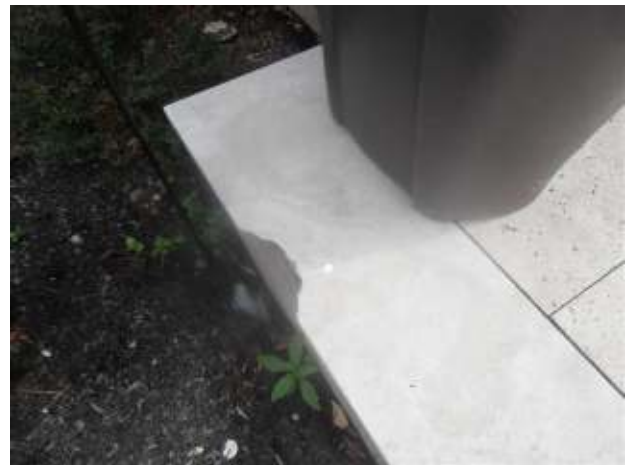
There are several damaged areas on the exterior surfaces that needs repair and painting.

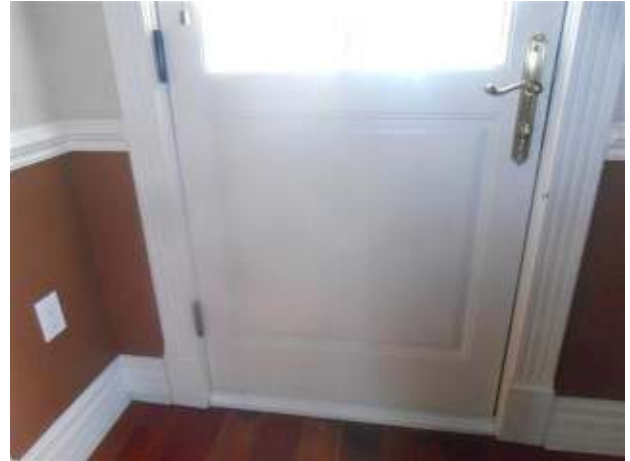
2 of the exterior wood doors have split lower panels that need to be replaced.

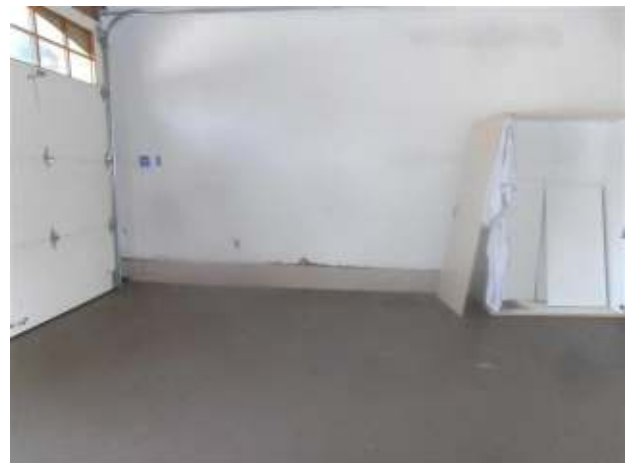
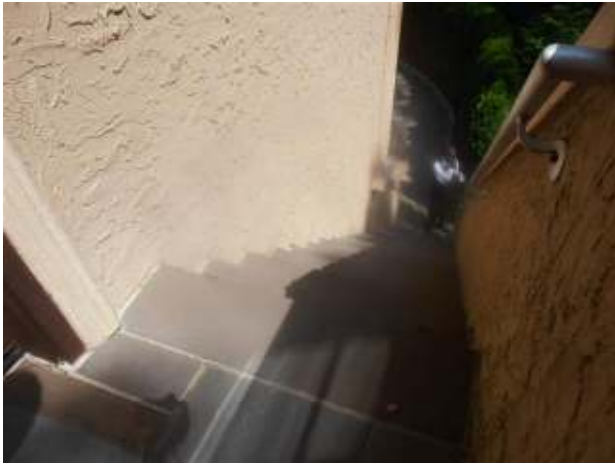
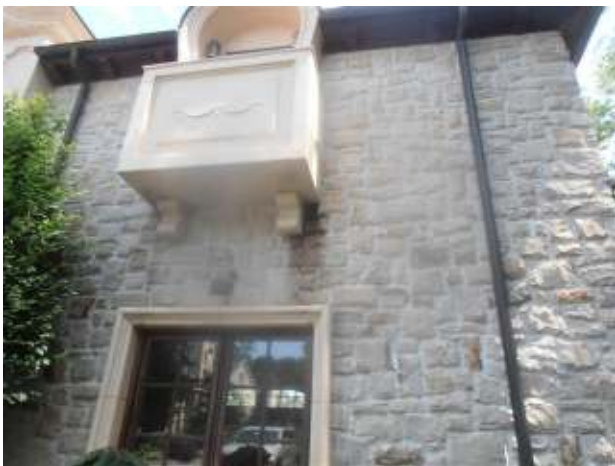
The wall in the left side garage that is very wet at the bottom with patch marks above needs to be opened up to determine where the water is coming from. There is a bathroom above this area that can have a leaking pipe or the water could be coming from the exterior steps along this wall. A company specializing in mold remediation will need to be consulted to determine if any mold or mildew exists behind the wall and what type of remediation will be required. These conditions can cause health problems.

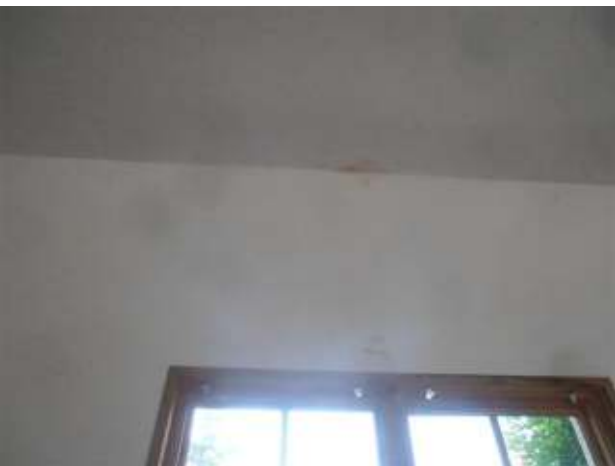
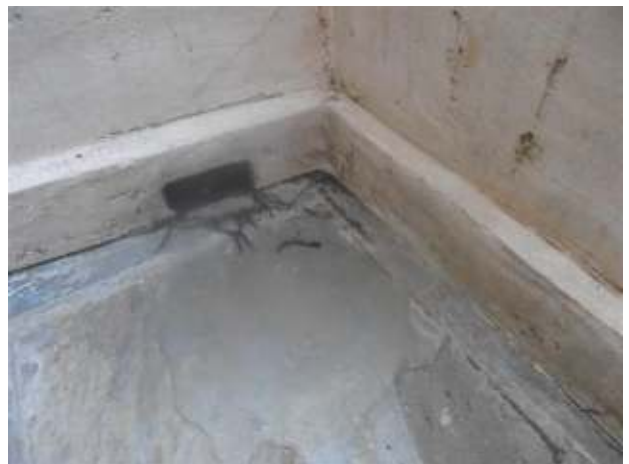
The front balcony above the garage that is causing water streaks on the exterior below the balcony and water stains on the garage wall needs to be corrected. If left as is continual water seepage into the walls can cause hidden damage that can result in a structural concern.

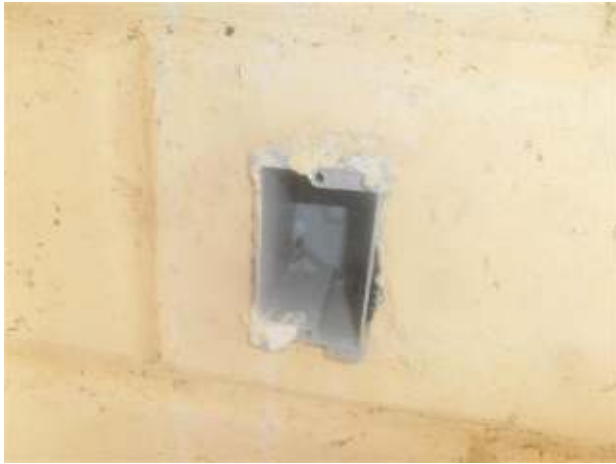
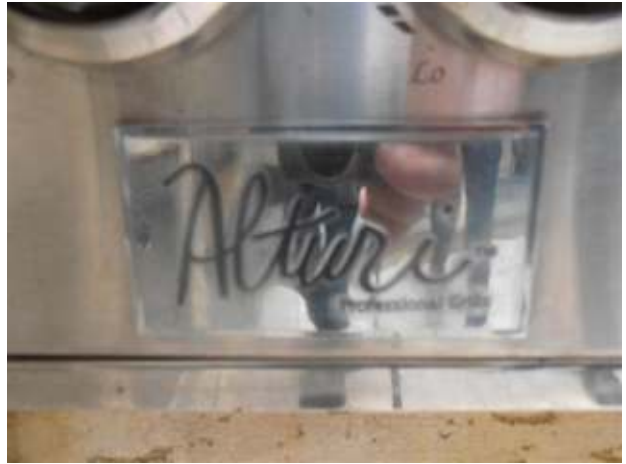
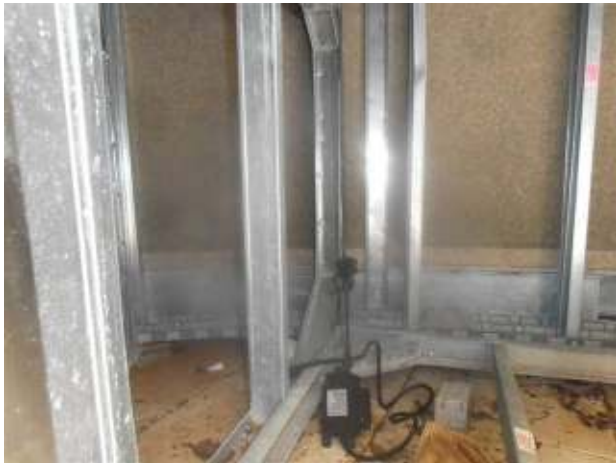
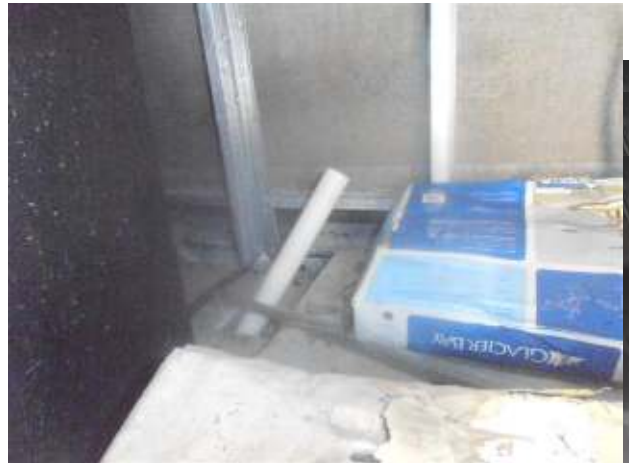
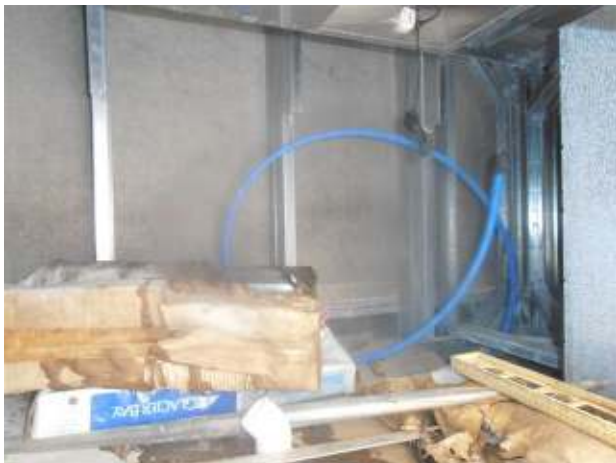
The rear yard kitchen needs to be completed. A faucet, water line and drain needs to be installed for the sink and no electric is provided for the refrigerator and grill igniters.

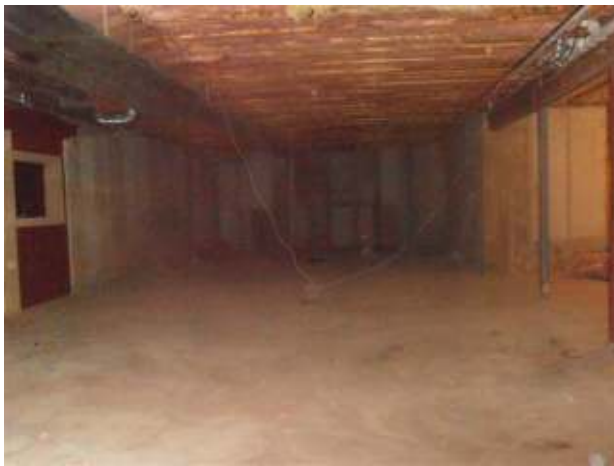
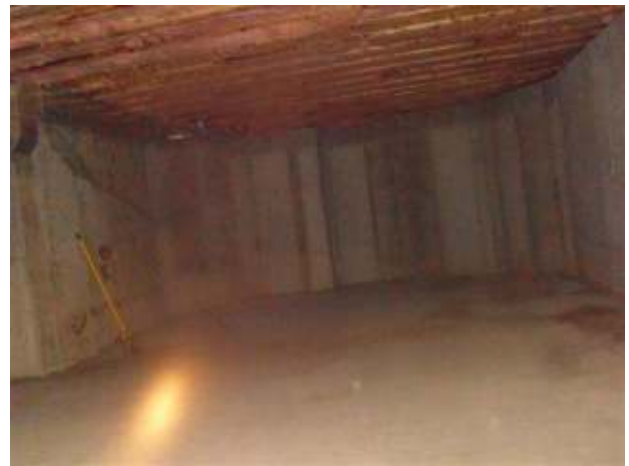
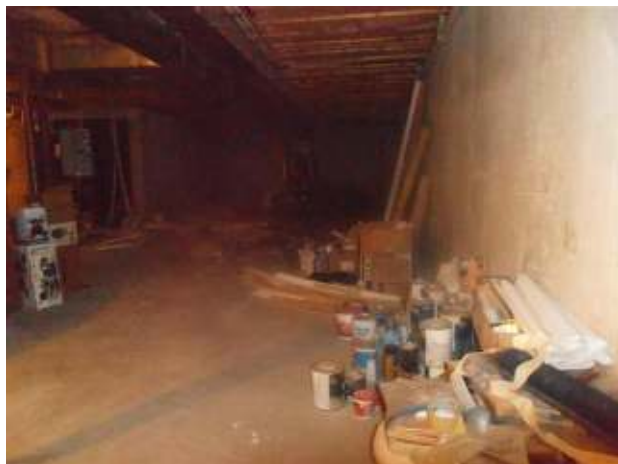
There is a lot of left over building debris in the basement that need to be removed.

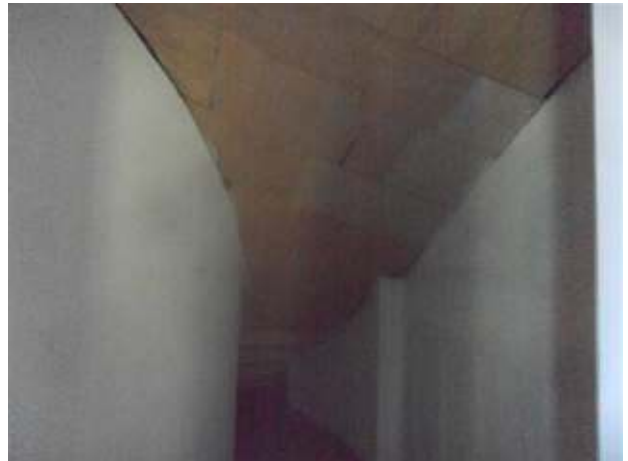
The living room closet door needs to be replaced and the interior of the closet professionally finished.

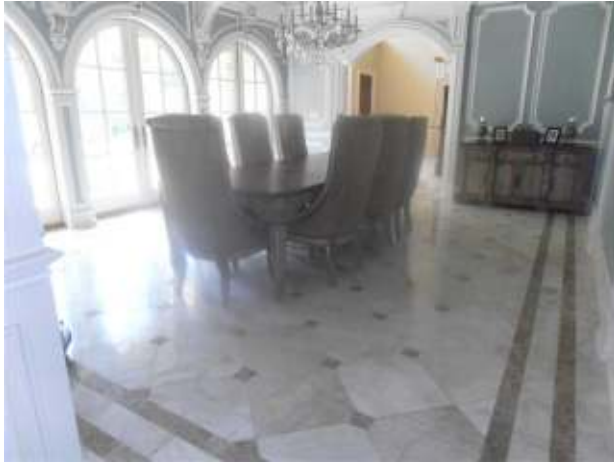
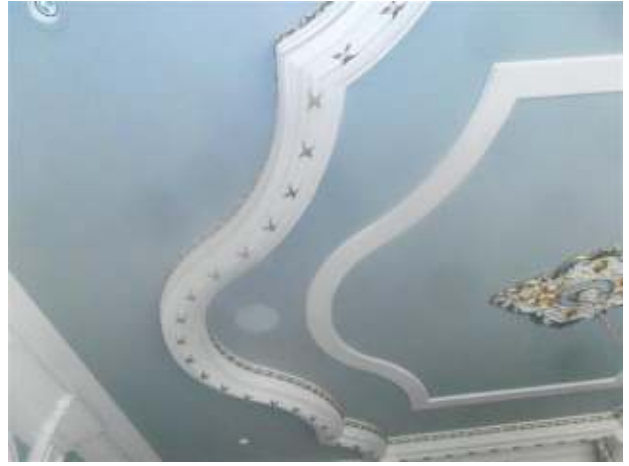
There are water stains on the dining ceiling most likely from the roof leaking the bathroom above that needs to be repaired.

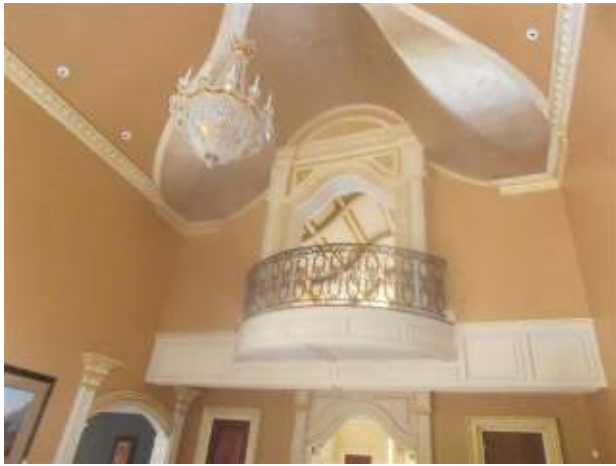
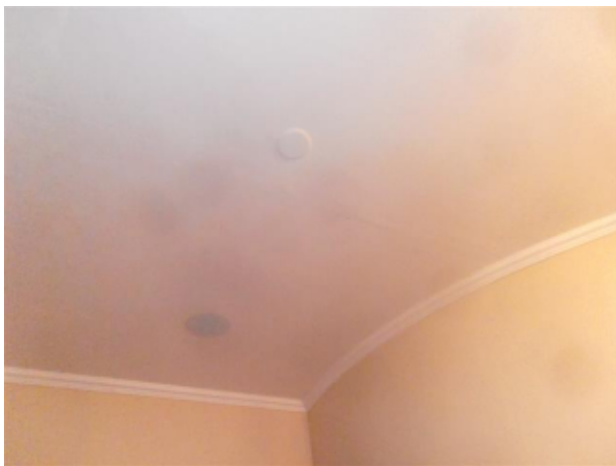
The ceiling in the office that has been repaired from a water leak needs to be professionally repaired.

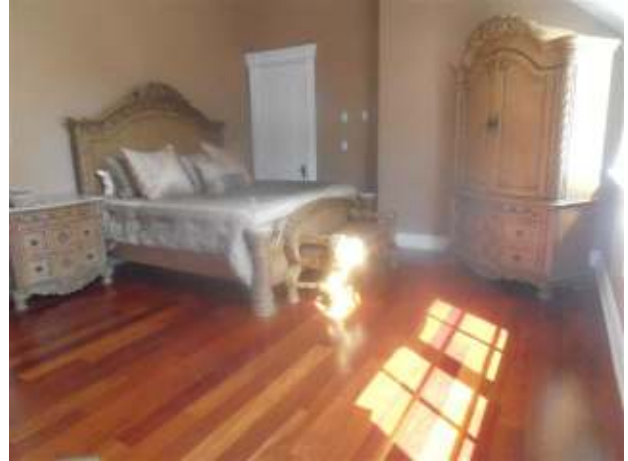
Some of the interior doors will require adjustment to the strike plates to stay closed.

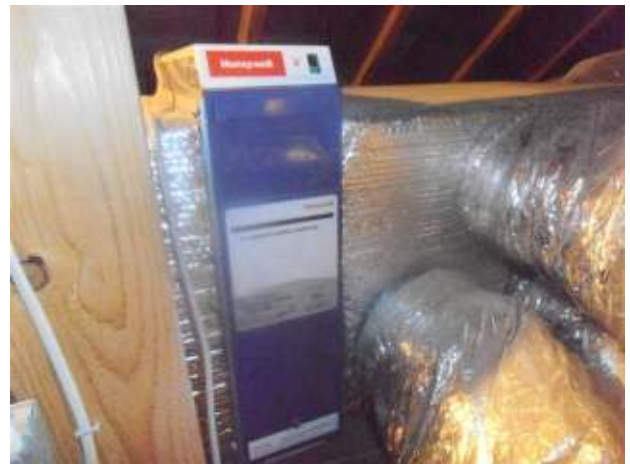
The electric filter for the attic air handler that is missing one of the filters needs to have a new one installed.

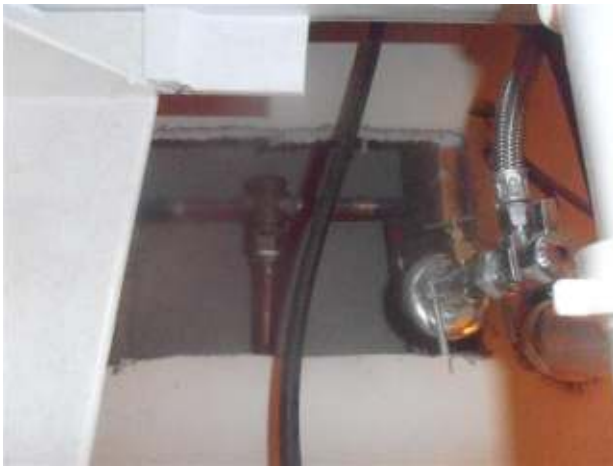
Laundry appliances are not evaluated within the scope of a home inspection. The piping under the laundry room sink has been repaired but the wall now needs to be closed up.

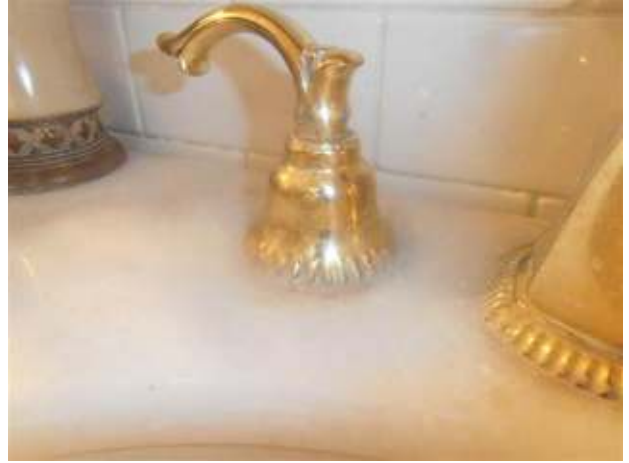
A lot of the bathroom fixtures are starting to pit and will need replacement

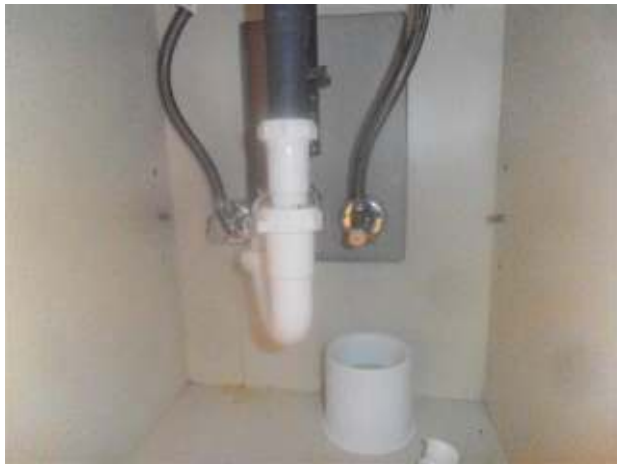
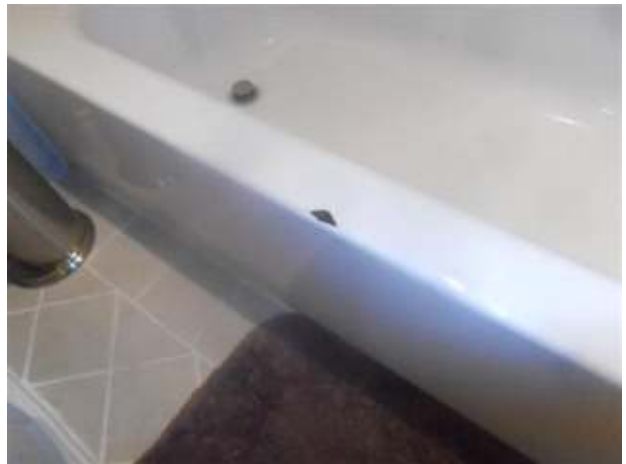
The leaking bathroom sink faucet needs replacement and the chipped tub needs replacement.

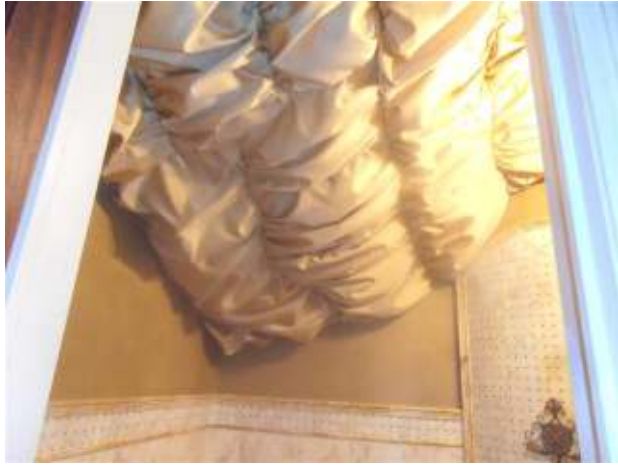
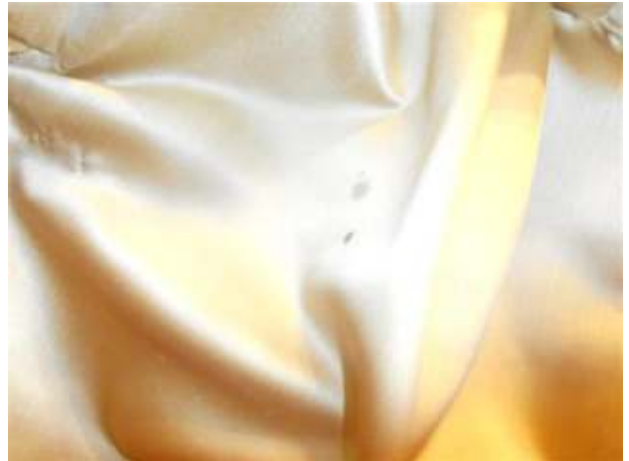
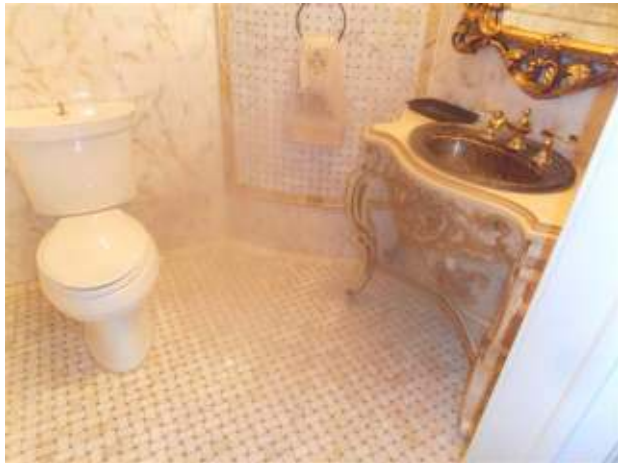
The 1<sup>st</sup> floor bathroom ceiling that is covered with cloth needs to be professionally finished and the exhaust fan exposed.
