# All Pro Home Inspections

Date of Inspection: Monday, July 07, 2014

**8 Pond View  
Montville, NJ 07045**

## HOME INSPECTION REPORT

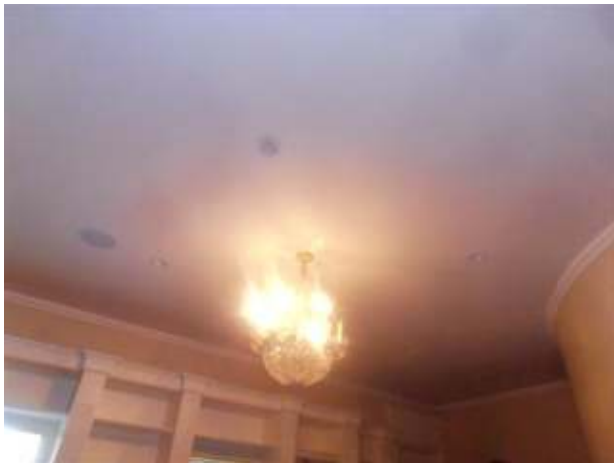
The ceiling lights in the office that are not working needs to be repaired.
