# All Pro Home Inspections

Date of Inspection: Monday, July 07, 2014

**8 Pond View  
Montville, NJ 07045**

## HOME INSPECTION REPORT

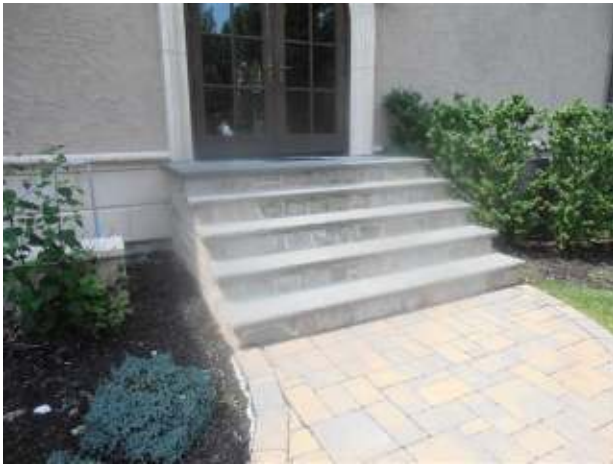
The rear steps need to have railings installed on both sides.

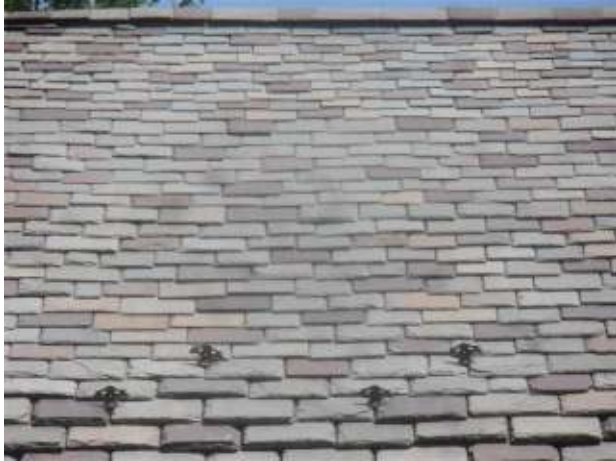
The slate roof appears to be in overall adequate condition. A roof of this type has an indefinite overall life expectancy if maintained. It needs to be inspected even few years by a roofing contractor specializing in this type of installation to determine the exact need for any maintenance in regard to the loose and missing slates that may occur over time. A roofer also needs to check the valley flashing for deterioration and any other repairs that are not apparent from the ground.

There is evidence of a leak in the front bedroom from ice damming over the winter that needs repair. The slates will need to be removed around this area to installed better flashing and ice and water shield to prevent this leak from occurring again.

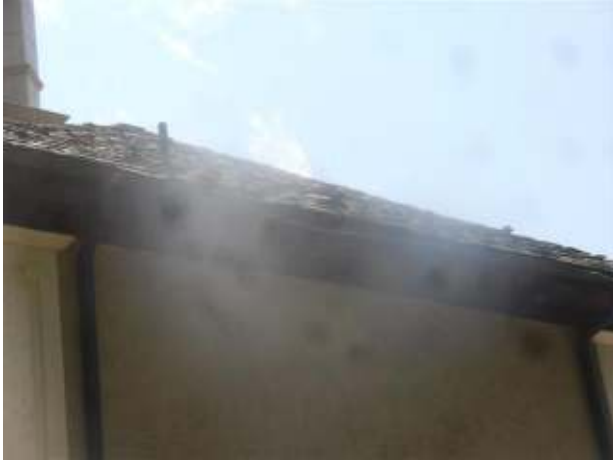
The rear gutter that has damaged by a fallen tree needs repair and the slate roof around this area needs to be checked and repaired.

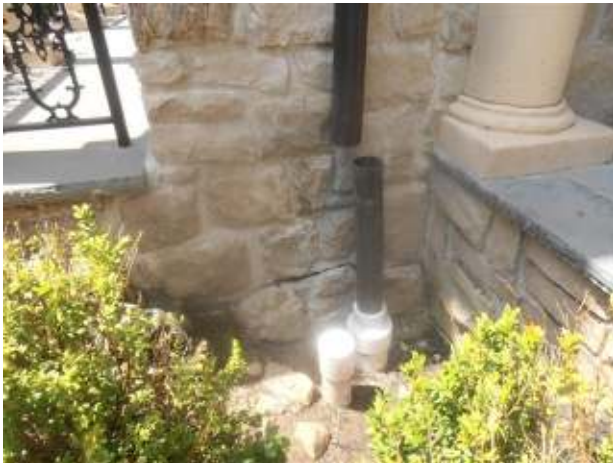
The front leader that is disconnected from the underground piping needs to be reconnected and the ground filled in .

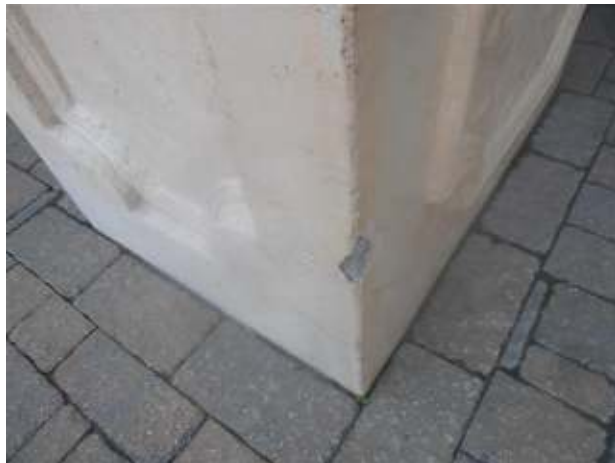
There are several damaged areas on the exterior surfaces that needs repair and painting.

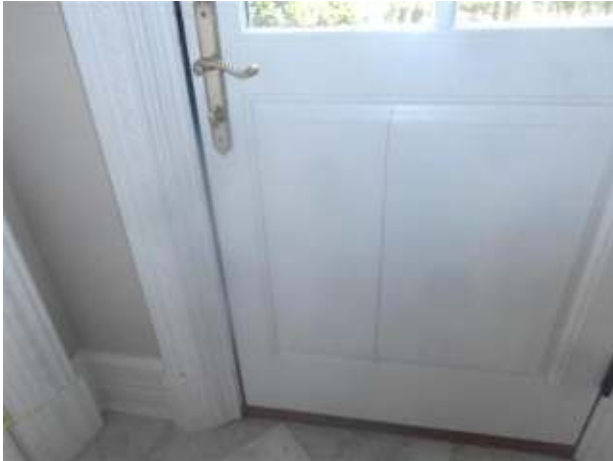
2 of the exterior wood doors have split lower panels that need to be replaced.

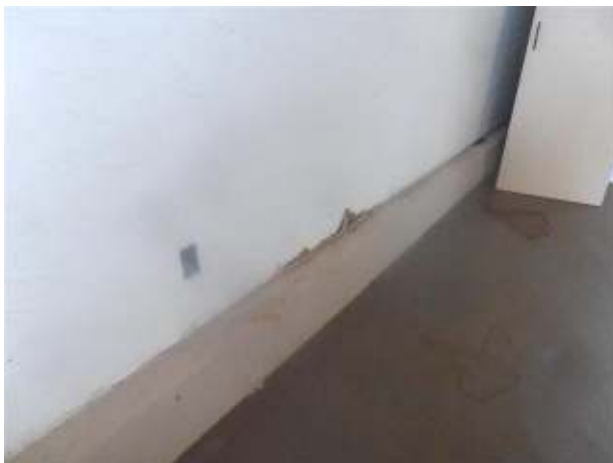
The wall in the left side garage that is very wet at the bottom with patch marks above needs to be opened up to determine where the water is coming from. There is a bathroom above this area that can have a leaking pipe or the water could be coming from the exterior steps along this wall. A company specializing in mold remediation will need to be consulted to determine if any mold or mildew exists behind the wall and what type of remediation will be required. These conditions can cause health problems.

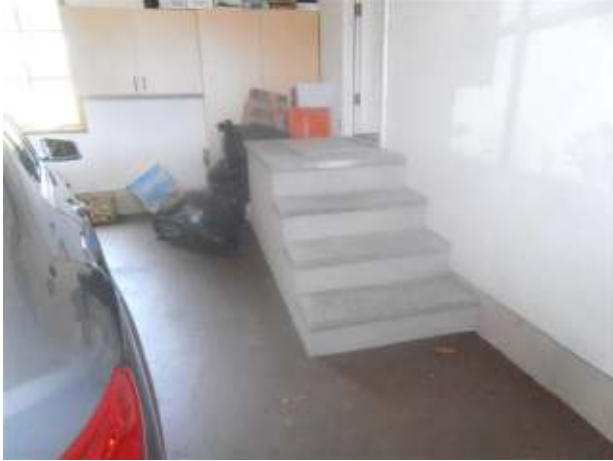
The steps in the garage needs to have a railing and banister installed.

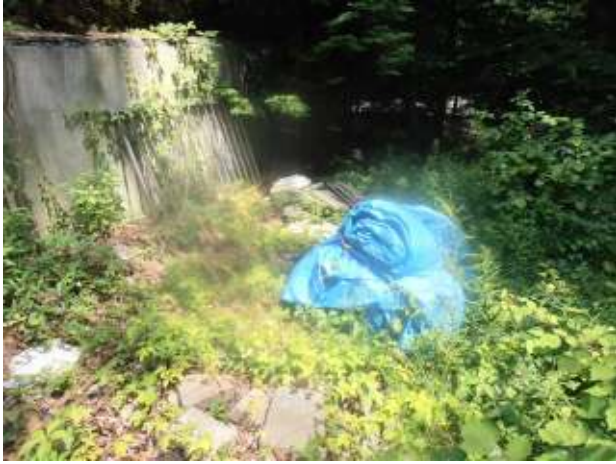
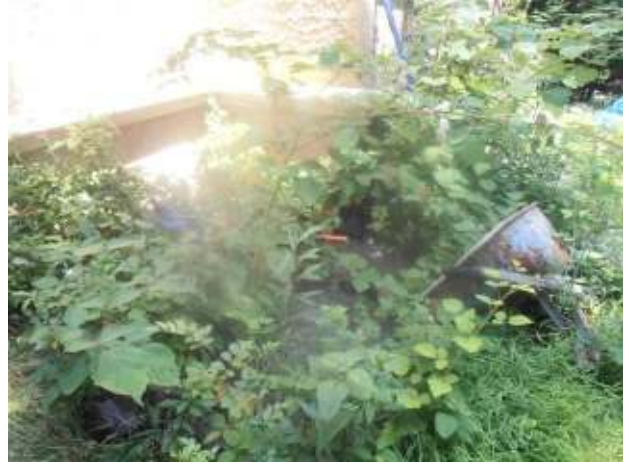
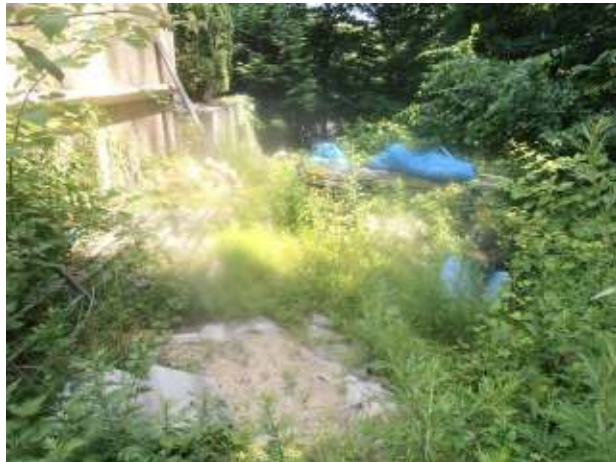
There is a lot of left over building debris in the side yard that need to be removed.

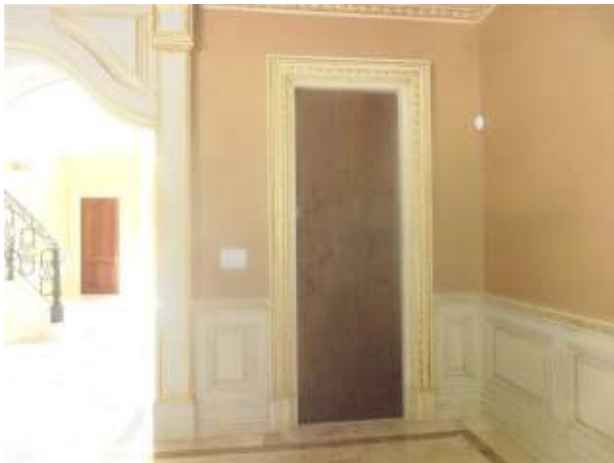
The living room closet door needs to be replaced and the interior of the closet professionally finished.

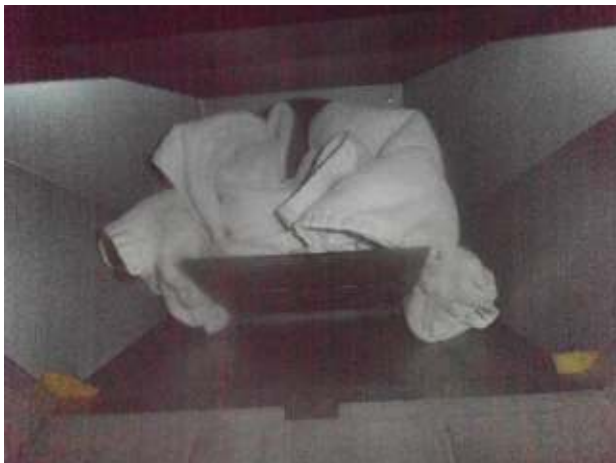
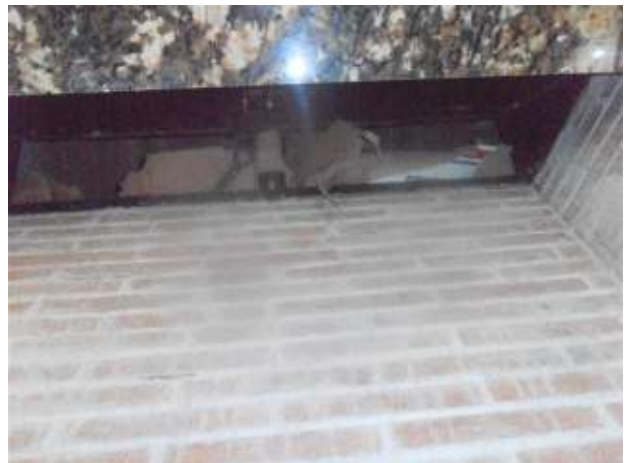
All the fireplaces needs to be looked at and made functional. Some have stuffed rags in the dampers and some of the fireplace dampers are not functional. Some do not have glass fronts. These installations are not operated to evaluate their performance during an inspection and no determination could be made as to how well they will draft during operation. Flues should be professionally cleaned on a regular schedule based on the frequency of use.

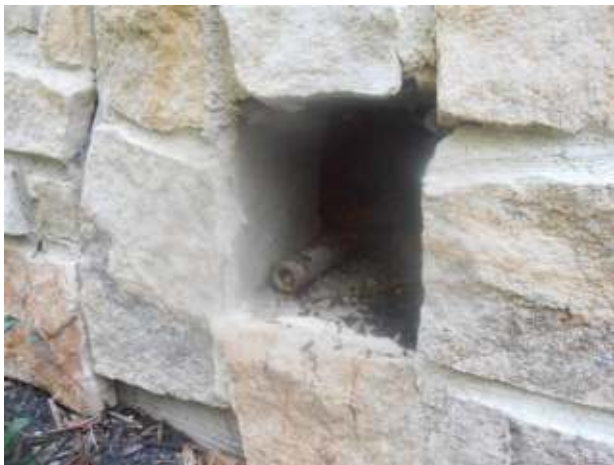
The open exterior fireplace ash pit needs to be covered.

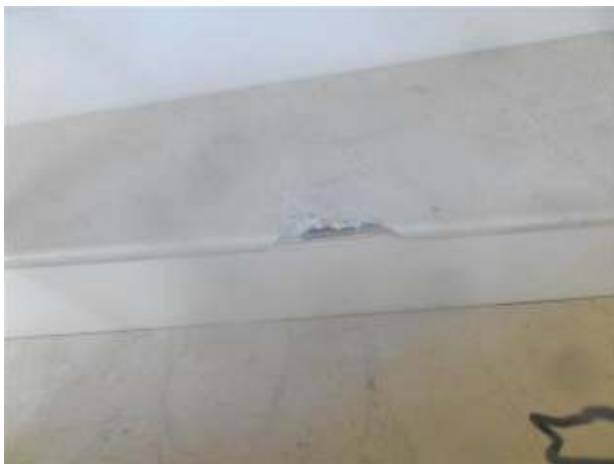
The cracked step to the 2<sup>nd</sup> floor needs replacement.

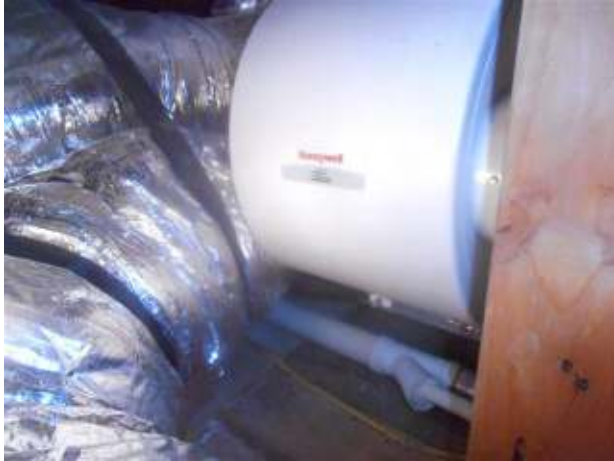
It is highly recommended that the humidifier in the attic be disconnected to prevent the water line from freezing in the winter and leaking.

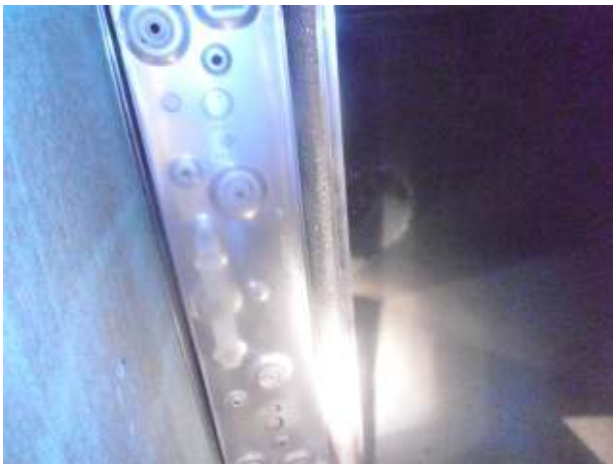
The electric filter for the attic air handler that is missing one of the filters needs to have a new one installed.

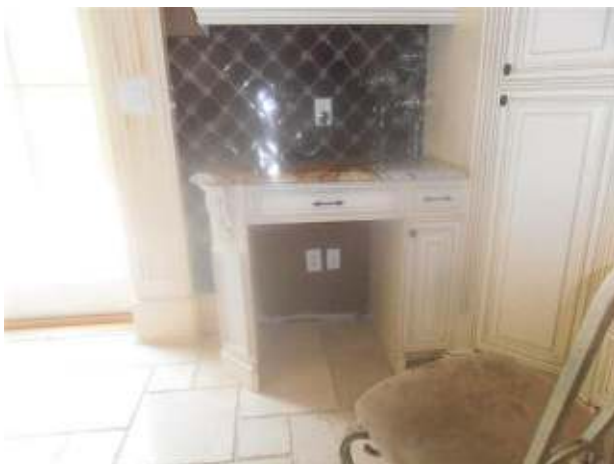
The wall under the desk in the kitchen needs to be finished.

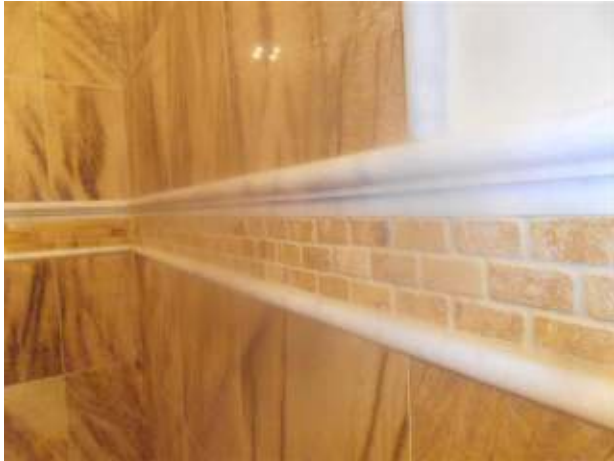
All of the bathroom shower stalls need to have glass doors installed.

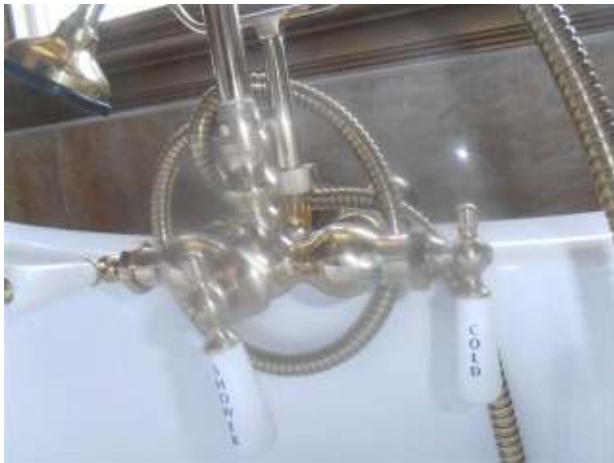
The cracked master bedroom tub faucet needs replacement.

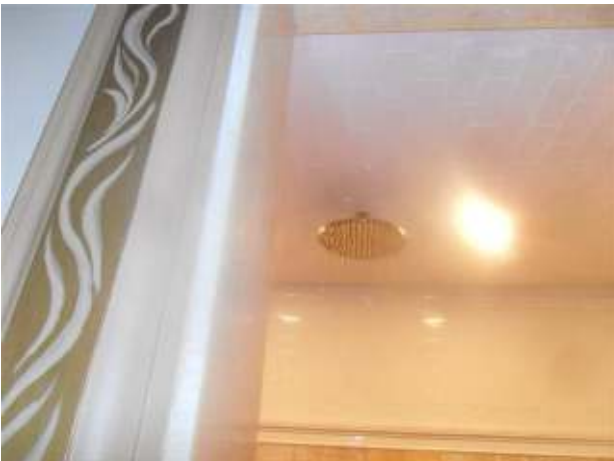
The defective master bedroom shower head needs replacement.

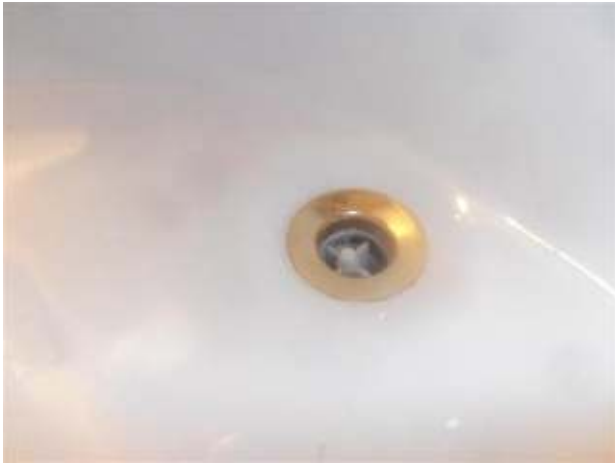
The master bathroom left side sink stopper needs repair.

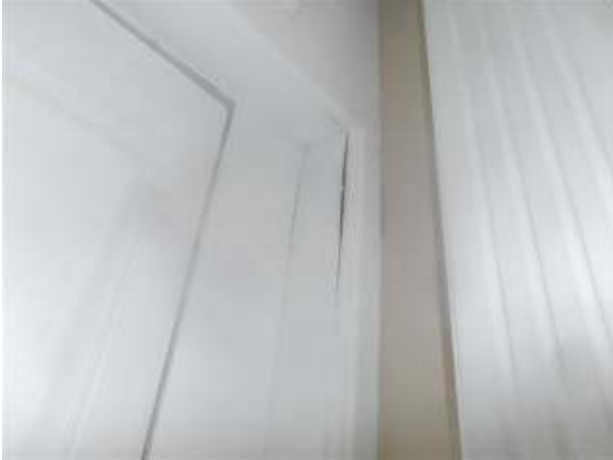
The molding on the bathroom door frame that is coming loose needs repair.
